Settling Time of Model 84053 Ceramic Sensors

Tech Note

84053 Ceramic Sensor Settling Tests

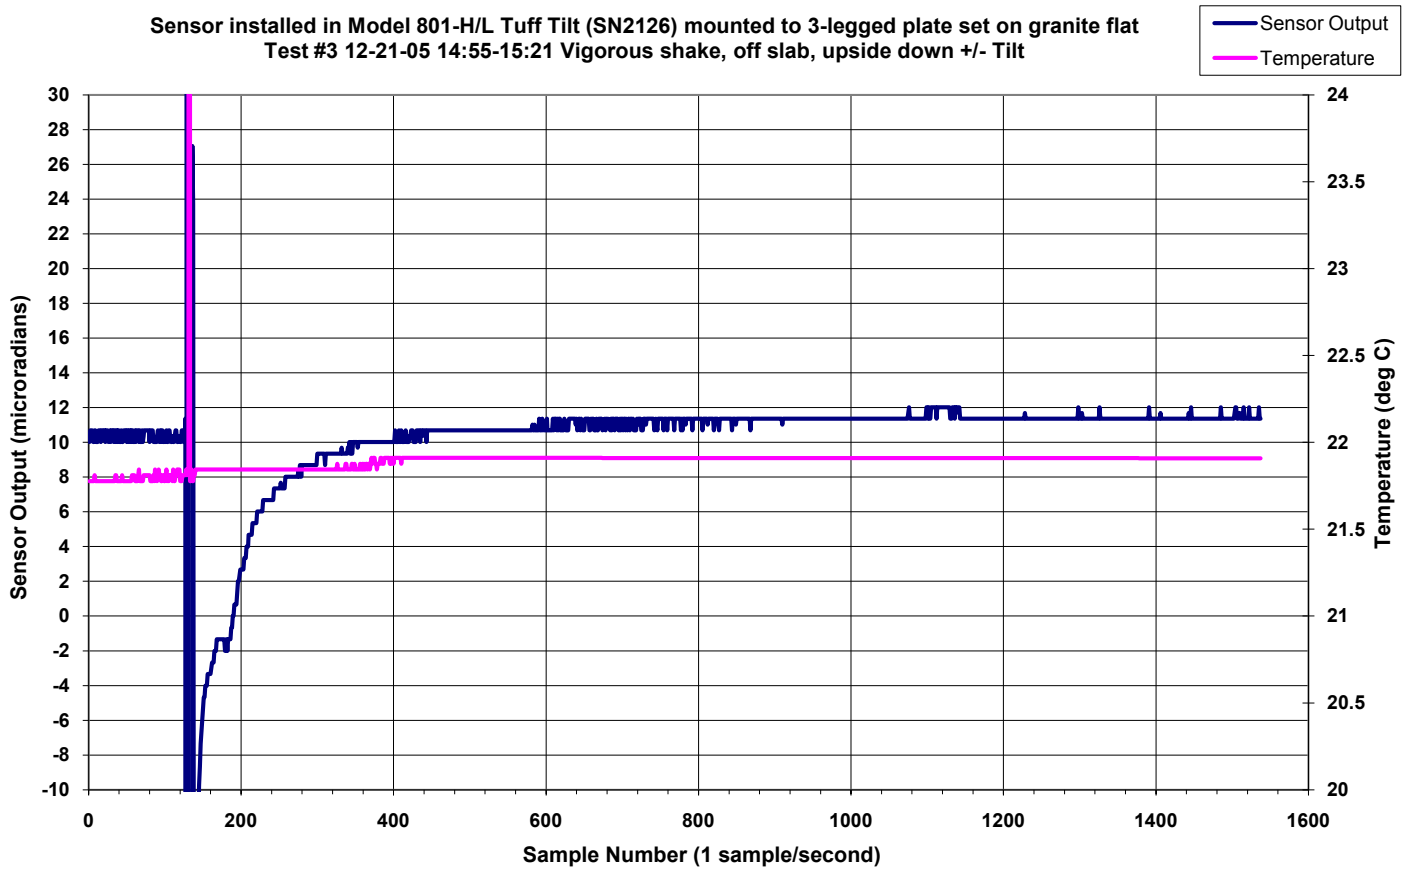
Sensor installed in Model 801-H/L Tuff Tilt (SN2126) mounted to 3-legged plate set on granite flat
Test #3 12-21-05 14:55-15:21 Vigorous shake, off slab, upside down +/- Tilt
